New Braunfels Independent School District
New Braunfels
High School Stadium

Facility Assessment & Planning Options

February 19, 2015

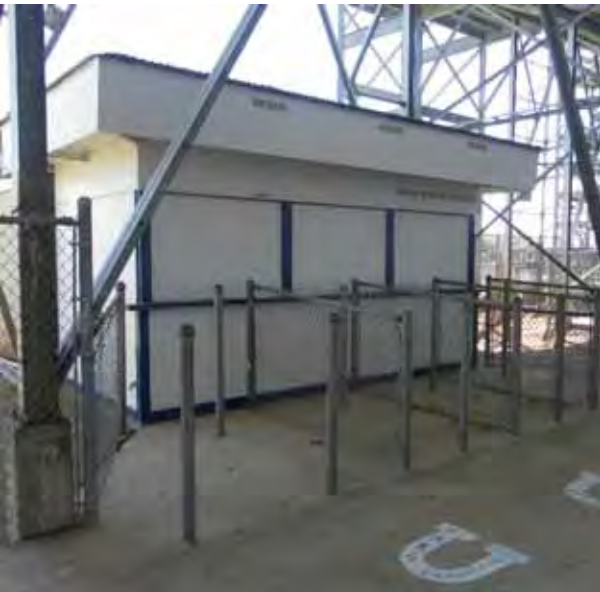
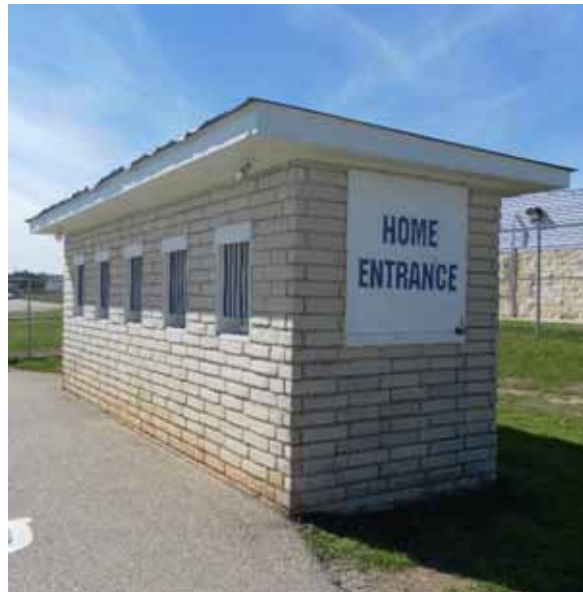
Stadium Track and Field

The football playing field is artificial turf. Both the turf and track were replaced in 2009 and have been very well maintained and indicate minimal wear. The half-circle ("D") areas adjacent to each end zone were also infilled for track and field events during the 2009 renovation. Track and field will not require any additional work at this time.

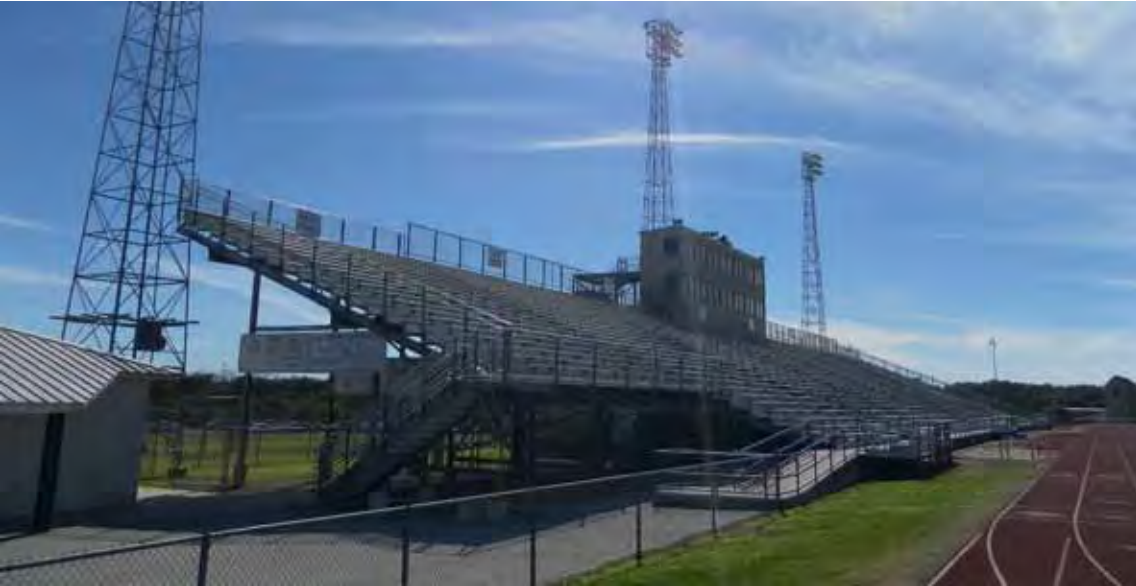
Stadium Bleachers – Home Side

The overall condition of the home side bleachers of Unicorn Stadium is GOOD. The structure is galvanized steel which has maintained an acceptable appearance and structural integrity to date. Current total seating capacity is approximately 6,000 spectators based on 18" wide seats. The press box was constructed approximately 15 years ago and appears to be code compliant including an elevator. Accessible ramp has also been installed on the north end of the bleachers.

- According to the IBC, 6,000 spectator seats would require a total of 40 wheelchair spaces as well as 40 companion seats.
- Open risers at seating.
- Lighting levels for the playing field need to be verified and possibly upgraded.
- Home side bleachers currently face towards the west causing harsh sun exposure in the evening.
- Vomitory ramps need to be reconfigured.

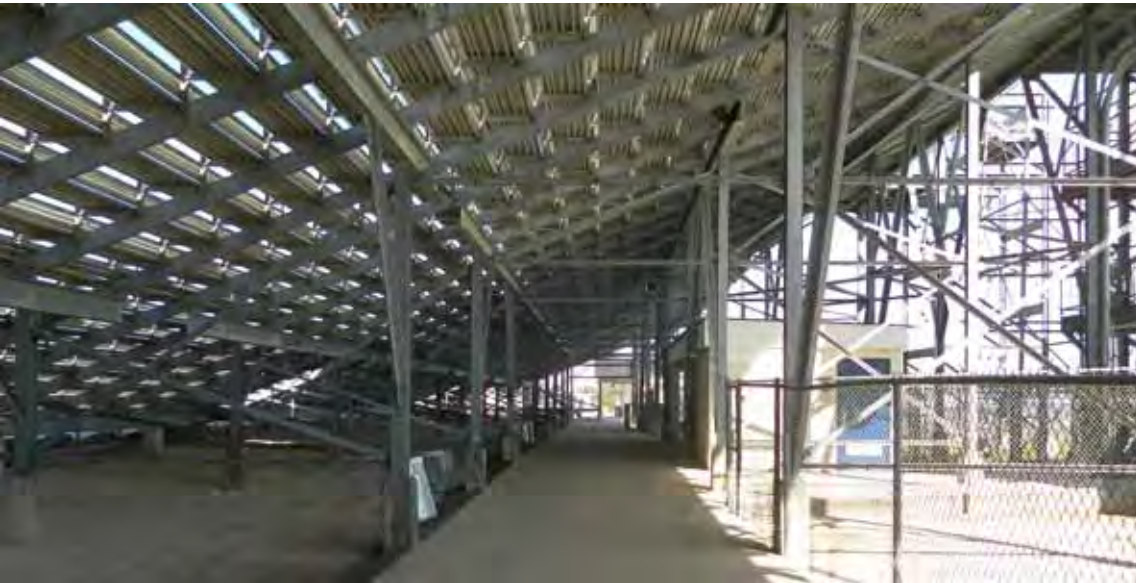
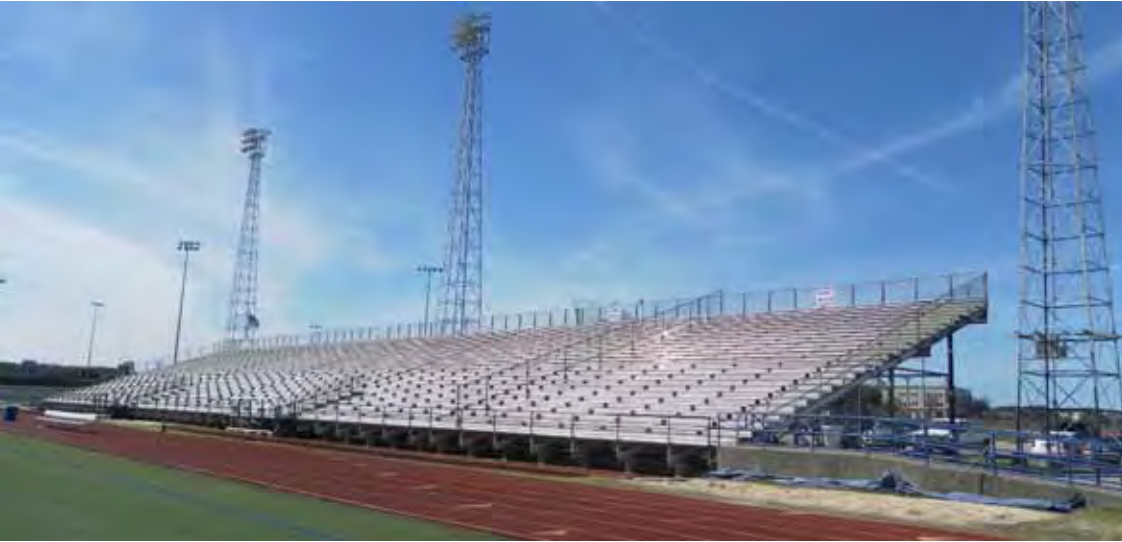
Stadium Bleachers – Visitor's Side

The overall condition of the visitor's side bleachers of Unicorn Stadium is POOR. The lower portion of the bleachers were constructed in 1954. The bleachers were expanded with the middle and top section in the mid 70's. The structure is painted steel and is currently rusting and oxidizing causing the finish paint to flake resulting in an unsatisfactory appearance throughout. Recommendation is to demolish the visitor's side bleachers.

- Wheelchair and companion seating spaces do not meet minimum code requirements.
- Open risers at seating.
- Condition of steel structure is unsatisfactory.
- Current seating capacity does not meet current and future venue needs.
- Lighting levels for the playing field need to be verified and possibly upgraded.
- Vomitory ramps would require reconfiguring.

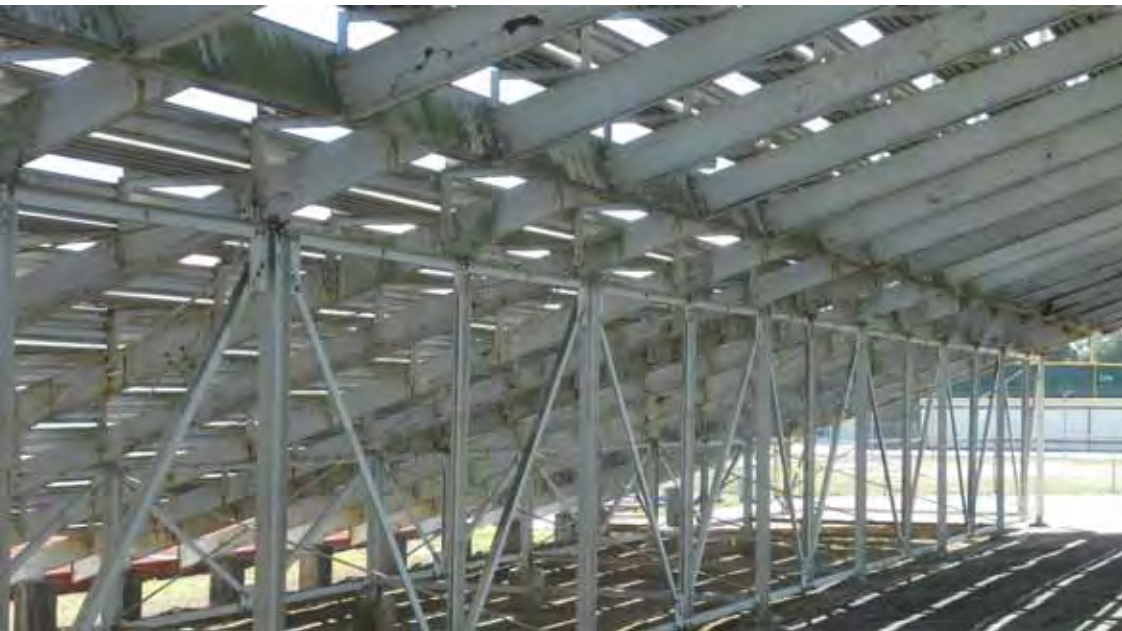
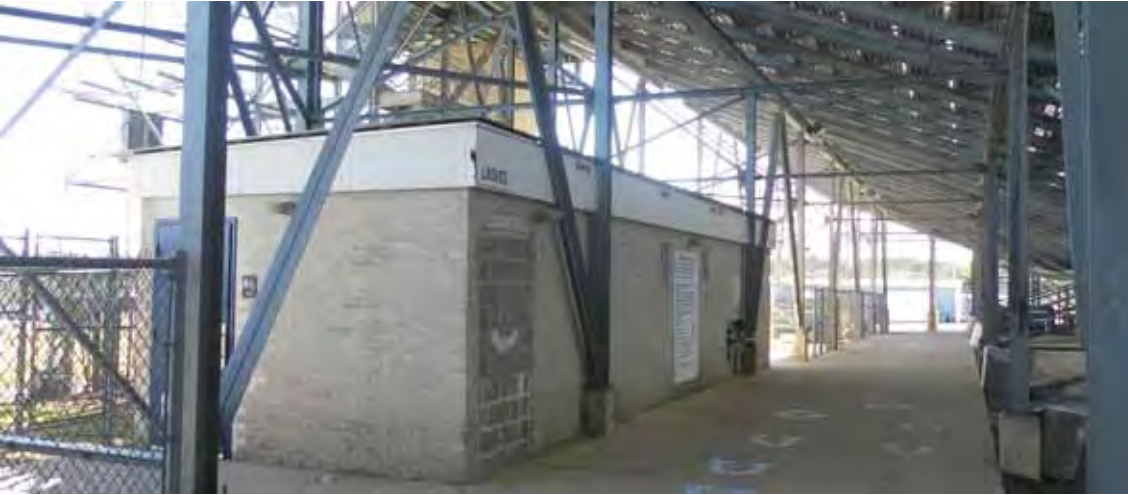
Restroom Building – Home Side

Building is approx. 500 sq. ft.. The overall condition of the restroom facility on the home side is POOR. The building currently contains a men's and women's restroom with a pair of drinking fountains on the exterior. The building is very dated and is showing a substantial amount of wear. Exterior wall patching has occurred where previous doors were located that does not match the remainder of the façade and the wood fascia contains damage and rotting has occurred in numerous locations. Recommendation is to demolish this structure and construct new restroom facilities.

- Current plumbing counts for this facility are as follows:
 - Men's Restroom = 6 Toilets
 - Women's Restroom = 4 Toilets
- Plumbing counts for existing, home side concession/restroom facility located at the northeast corner of the home side:
 - Men's Restroom = 10 Toilets
 - Women's Restroom = 8 Toilets
- According to Uniform Plumbing Code, toilets required per current spectator occupancy for future visitor's side are as follows:
 - Men's Toilets = 21 (Currently deficient by 5 fixtures)
 - Women's Toilets = 32 (Currently deficient by 20 fixtures)
- Modifications would be required to interior of restrooms to be code compliant.
- Drinking fountains are not code compliant.
- Ventilation is exhausted into the concourse area.

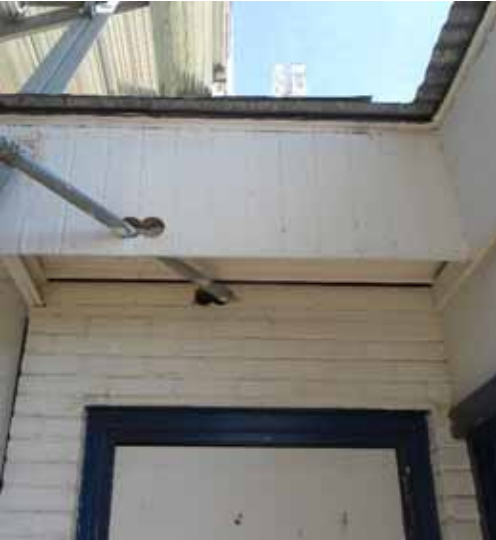
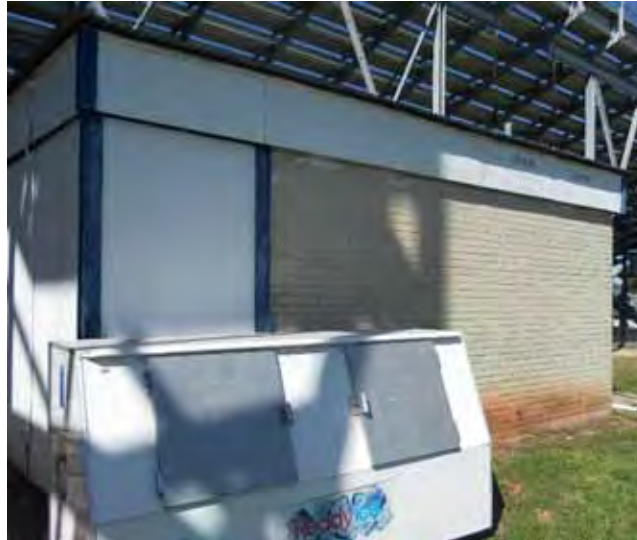
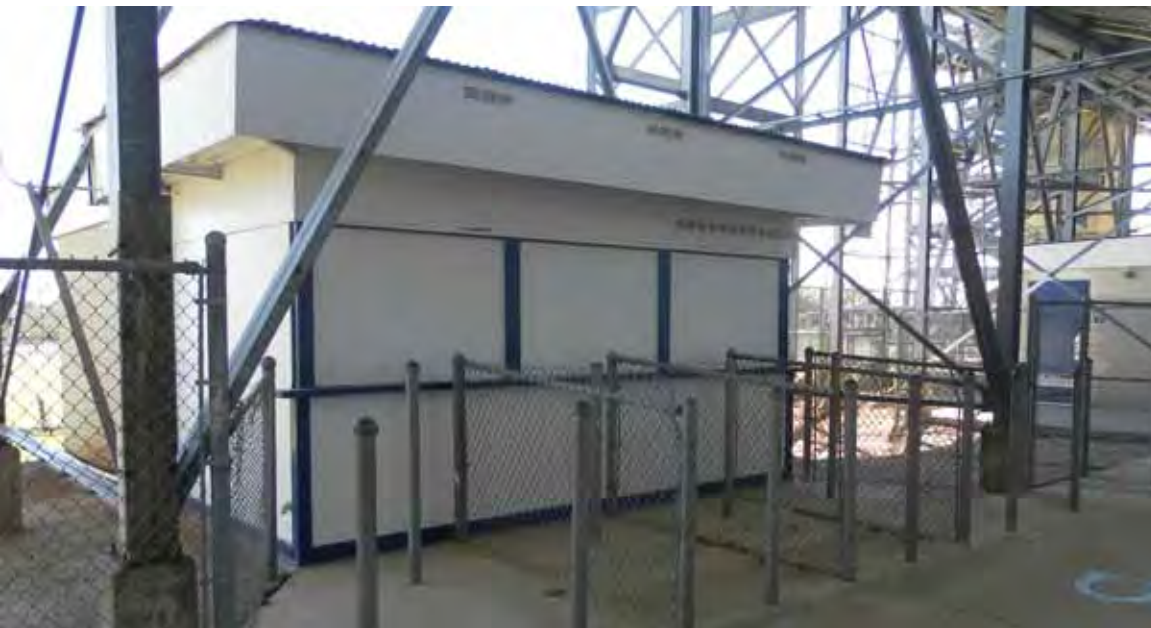
Small Concession Bldg. – Home Side

The overall condition of the concession facility on the home side is POOR. The building is very small and does not currently accommodate the equipment required to serve as needed (ex. Ice storage is currently located outside, behind the building. Recommended to add ice machines inside in lieu of ice storage). Significant wear is evident on the interior and exterior of the building. Recommendation is to demolish this structure and construct new concession facilities or expand newer, concession/restroom building to the north.

- Modifications would be required to interior of building to be code compliant.
- Queuing area is limited and not ADA compliant.
- Ventilation is exhausted into the concourse area.
- No accessible route into the building.
- Existing steel structure for bleachers penetrates the envelope of the building in several locations.
- Portion of building plumbing is exposed, above grade.

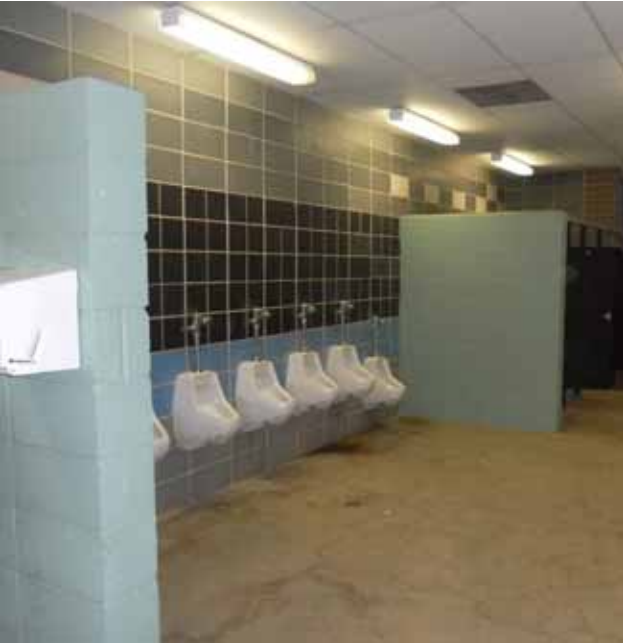
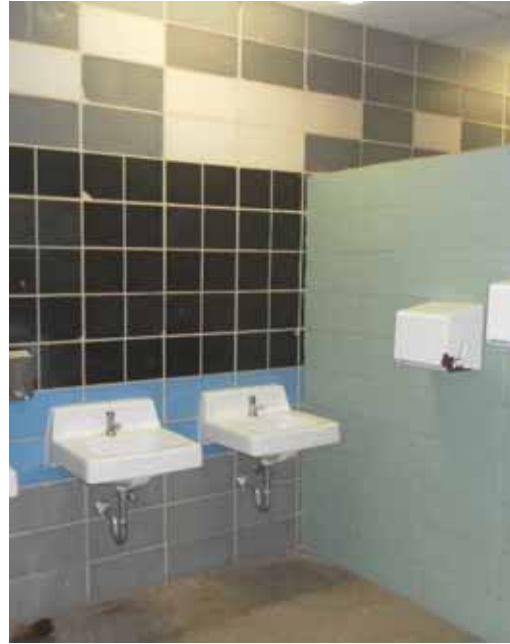
Concession/Restroom Bldg. – Home Side

The overall condition of the concession/restroom facility on the home side is FAIR. The building appears to be newer than most structures supporting the stadium. Some modifications would be required to bring the restrooms up to current code standards. Interior and exterior finishes would need to be freshened up. Concession area is very restrictive and does not allow for optimal operation. Recommendation is to expand this building to create a larger concession area which would allow the building to be brought up to meet code requirements and provide more interior space for concession operations.

- Current plumbing counts for this facility are as follows:
 - Men's Restroom = 10 Toilets
 - Women's Restroom = 8 Toilets
- Plumbing counts for existing, home side restroom facility:
 - Men's Restroom = 6 Toilets
 - Women's Restroom = 4 Toilets
- According to Uniform Plumbing Code, toilets required per current spectator occupancy for future visitor's side are as follows:
 - Men's Toilets = 21 (Currently deficient by 5 fixtures)
 - Women's Toilets = 32 (Currently deficient by 20 fixtures)
- Building not ADA compliant.
- Concession area is very tight and needs expansion. Currently does not accommodate both cashiers and food preparation personnel.
- Currently does not accommodate soda fountains. All drinks are currently bottled and require storage space for refrigeration.

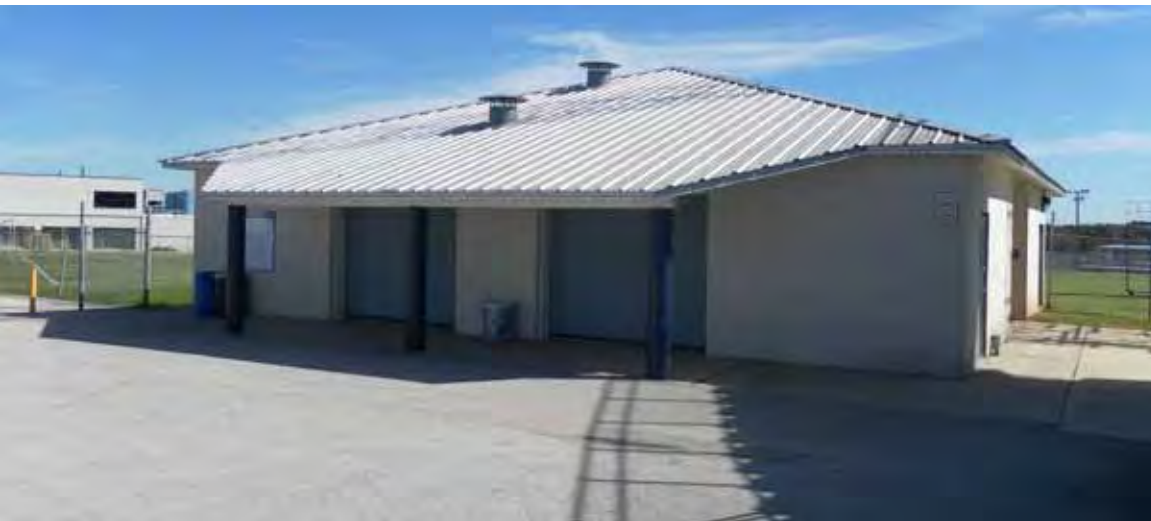
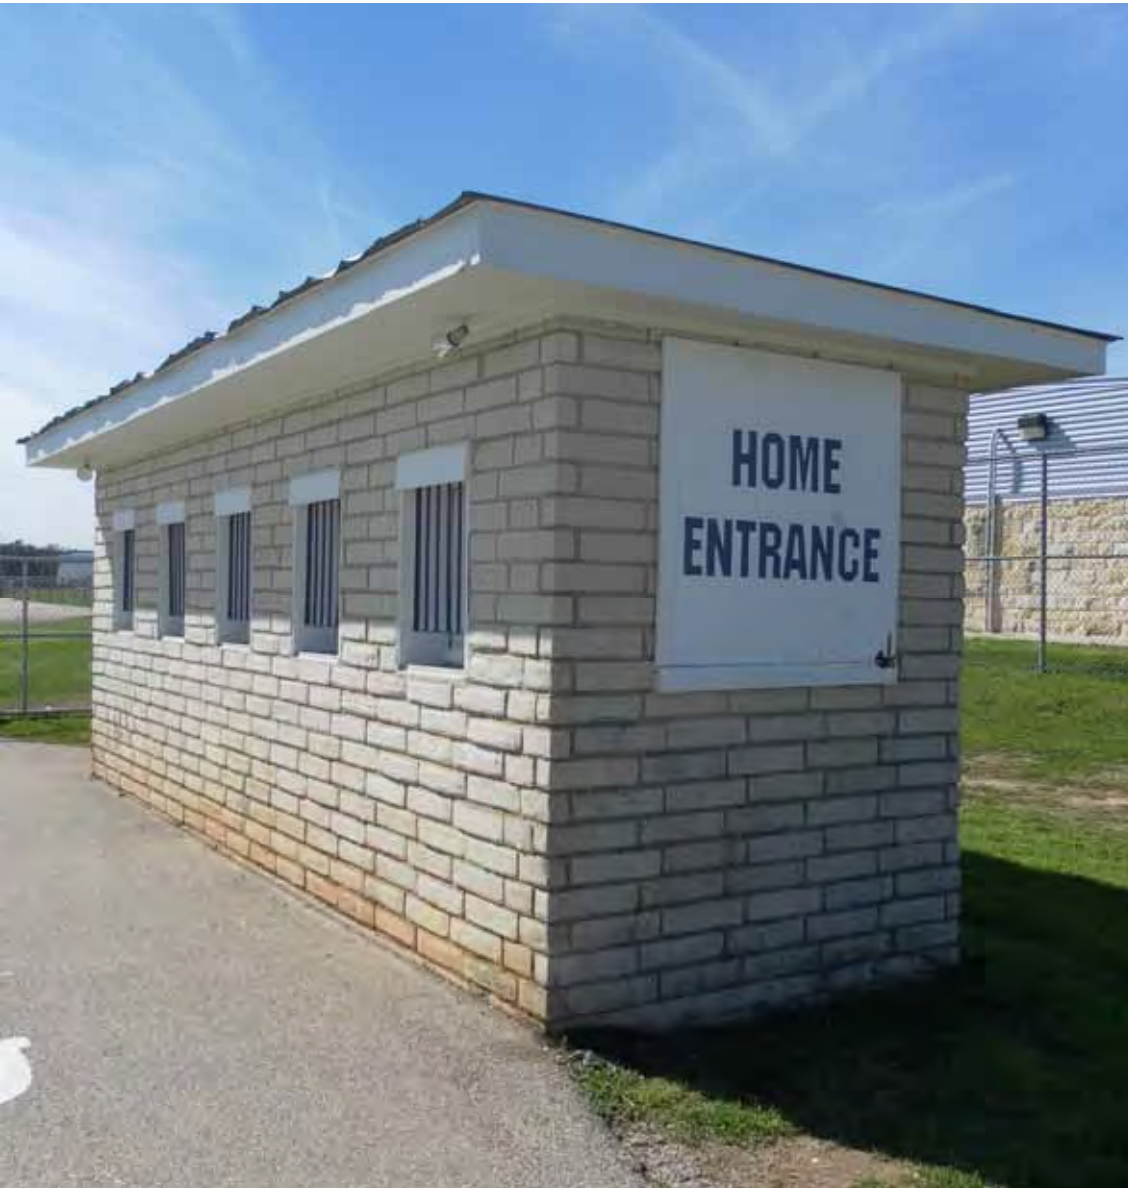
Ticket Booth – Home Side

The overall condition of the ticket booth on the home side is POOR. Significant wear is evident in both the interior and exterior of the building. Recommendation is to demolish the structure and build a new ticket office to serve the east side of the stadium.

- Building not ADA compliant.
- Interior of the building contains tight clearances that does not allow for optimal operation.
- Lighting is insufficient.
- Non air-conditioned.

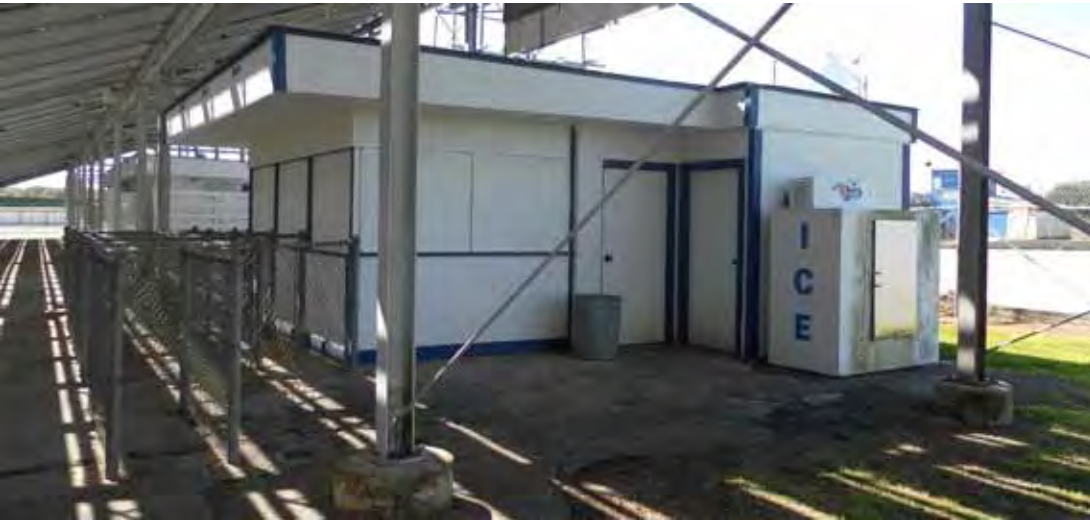
Small Concession Bldg. – Visitor's Side

The overall condition of the concession facility on the visitor's side is POOR. The building is very small and does not currently accommodate the equipment required to serve as needed (ex. Ice storage is currently located outside of the building. Recommended to add ice machines inside in lieu of ice storage). Significant wear is evident on the interior and exterior of the building. Recommendation is to demolish this structure and construct new concession facilities for the west side of the stadium.

- Modifications would be required to interior of building to be code compliant.
- Queuing area is limited and not ADA compliant.
- No accessible route into the building.
- Portion of building plumbing is exposed, above grade.
- Drinking fountains and approach to the fountains does not meet current code requirements.

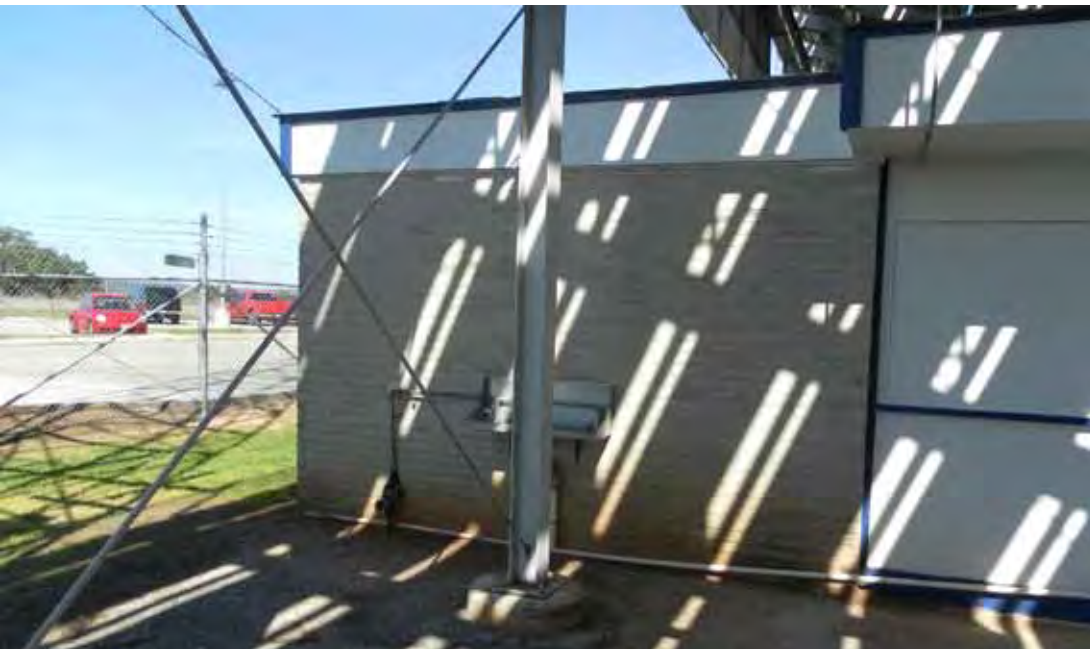
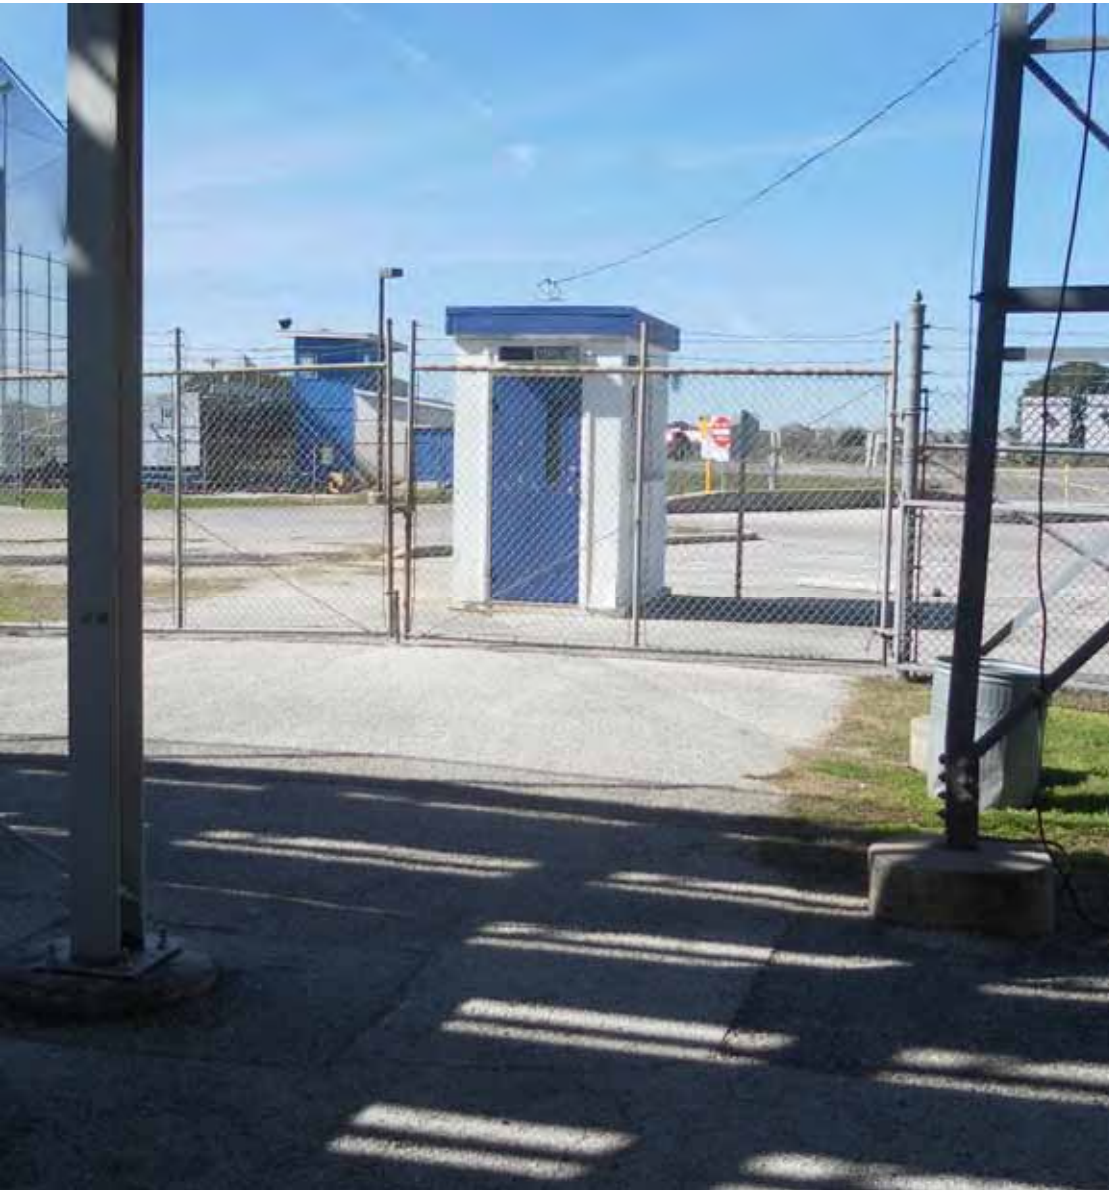
Ticket Booth – Visitor's Side

The overall condition of the ticket booth on the home side is POOR. Significant wear is evident in both the interior and exterior of the building. Recommendation is to demolish the structure and build a new ticket office to serve the west side of the stadium.

- Building not ADA compliant.
- Interior of the building contains tight clearances that does not allow for optimal operation.
- Lighting is insufficient.
- Non air-conditioned.
